# Hygiene (Dairy)

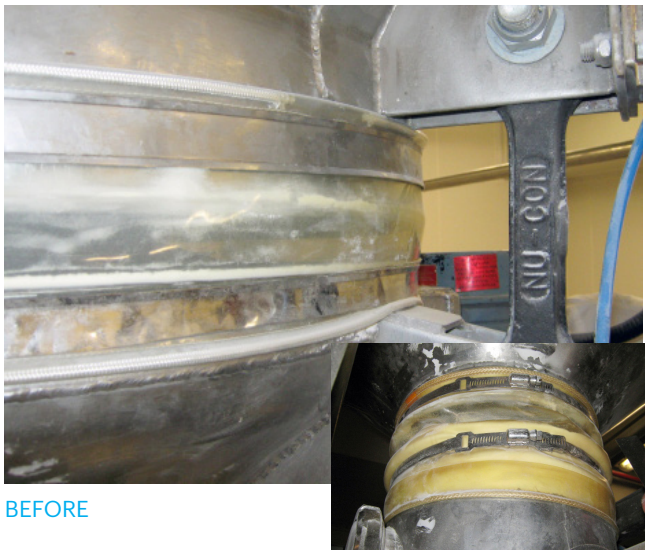
BEFORE

The regular gas purging of the system forced powder through small gaps in the old-style sock and steel clamp connector. This caused an unhygienic environment and hours of down-time for regular cleaning. There was also a major contamination point created by significant product build up between the externally fitted sock and hopper.

The steel strapping clamps were very time consuming to remove and re-fit during sock cleaning & replacement.

A leading New Zealand dairy plant had a major challenge with hygiene in their blending filler room. A vibratory discharging cone was connected to the hopper via a traditional connecting sock and steel clamps. There was excessive dust leakage and product build-up in the joins - a major hygiene issue. Since installing the BFM® fitting system, the room is clean and there has been a significant reduction in both downtime and replacement costs.

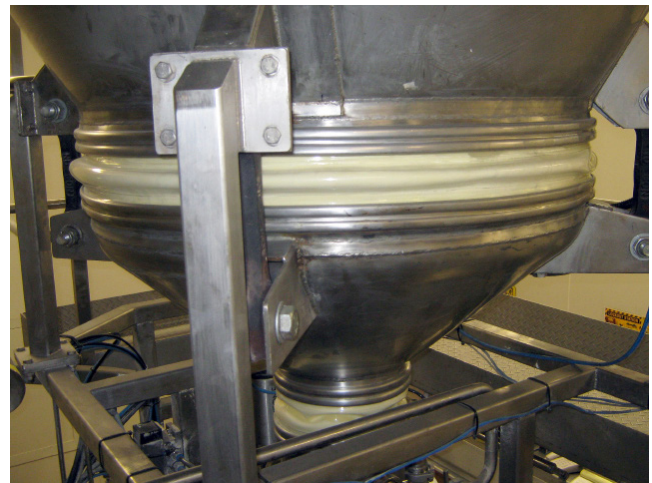
AFTER

The installation of a BFM® fitting for both the upper and lower connections has created a sealed system, and the filling room is now a dust-free environment. The pressure from the gas purging no longer causes product leakage, and because the fitting sits inside the spigot, there is no product build-up at the connector joins.

When the fittings do need replacing, it's now a quick and easy snap-fit process.

**IMPROVED HYGIENE:** The contamination point has been eliminated and no more product leakage has improved overall plant hygiene immensely.
